Volume V

Appendix G.8

**USING THE DATA AND OBSERVATIONS FROM FLIGHT STS-107 TO EXPLAIN THE
FATAL REENTRY OF THE COLUMBIA ORBITER OV-102**

By
DR. JOHN J. BERTIN
DR. JAMES W. SMILEY
CONSULTANTS, CAIB SUPPORT GROUP

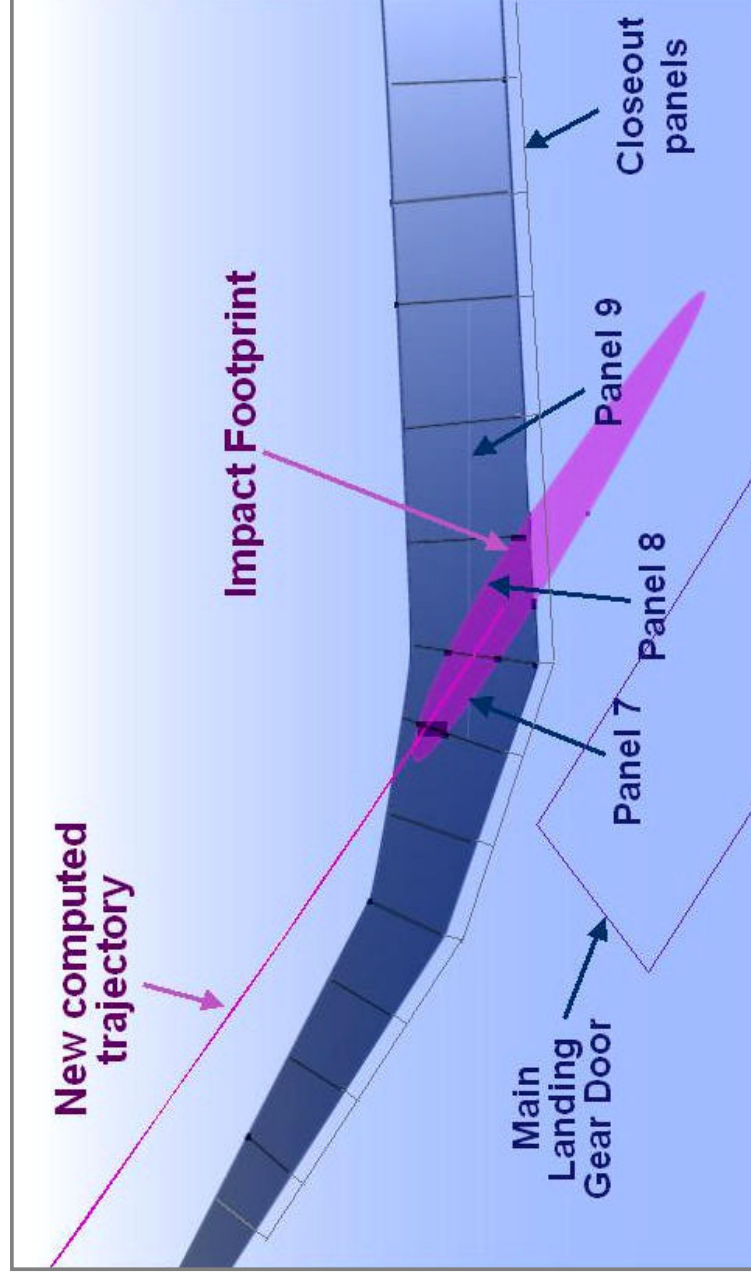
Figure 3

- Centerline of one-foot diameter trajectory “pipe” intersects the wing at approximately RCC panel 8, with the most likely foam impact predicted along panels 7 and 8

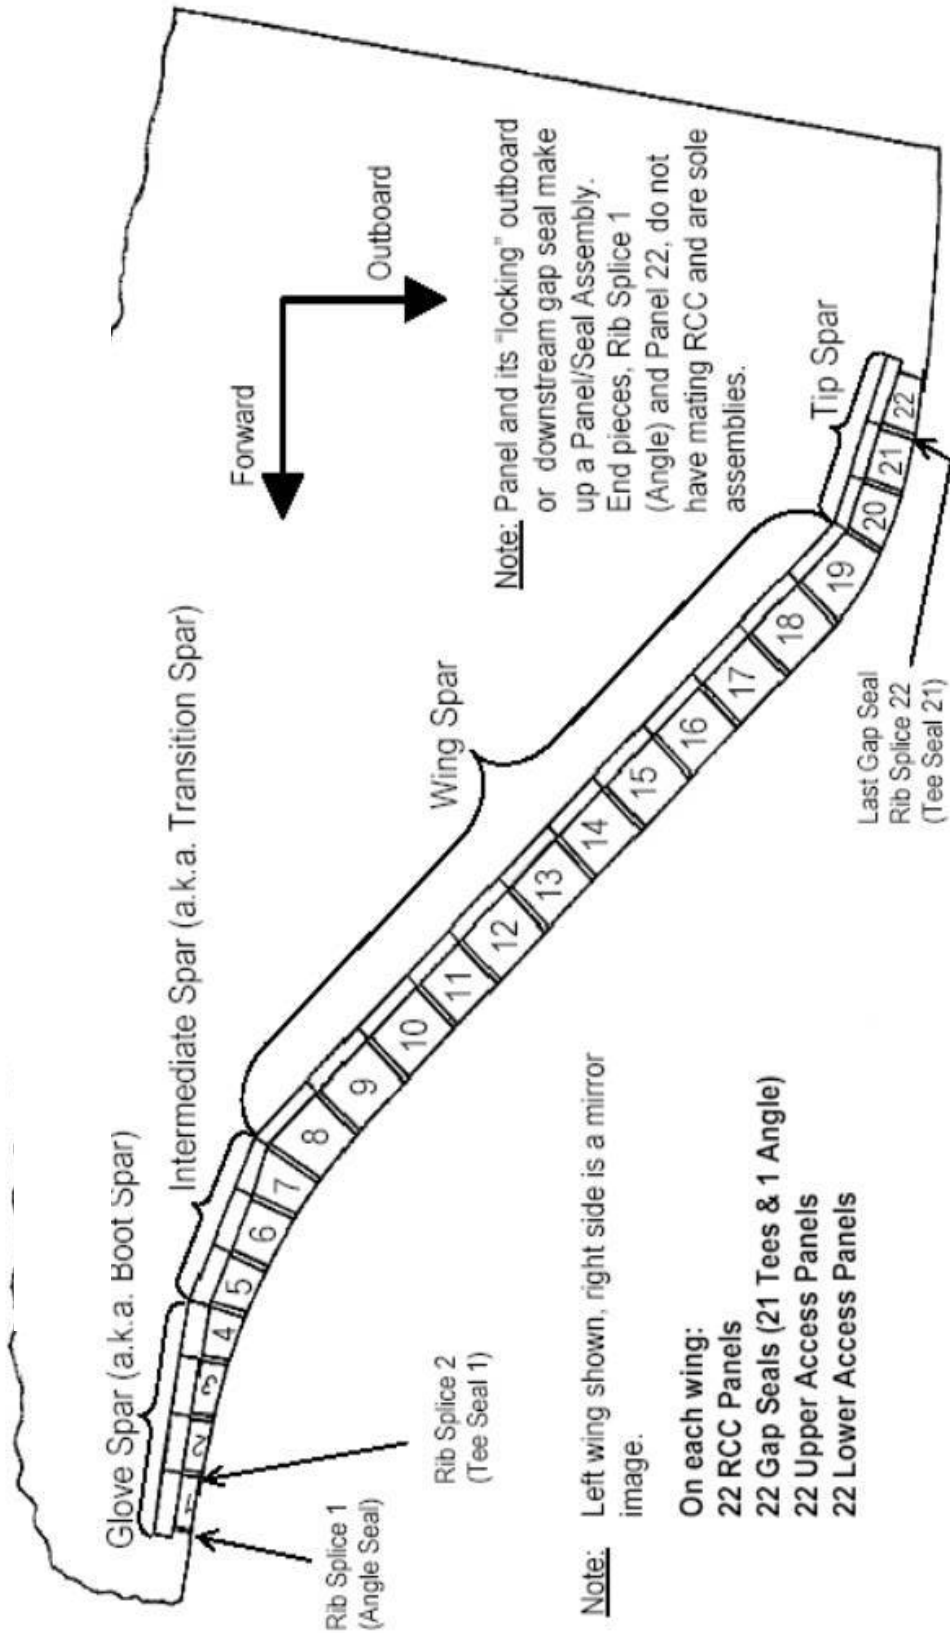
Figure 4

The wing-leading-edge subsystem (LESS) is shown in the sketch of Figure 4. The impact of the debris with a leading-edge RCC panel could have removed (all or part of) a T-seal or produced a hole or a crack in the RCC panel itself. In an attempt to further define the location and the extent of the debris-induced damage, NASA personnel and their contractors have been using computational fluid dynamic (CFD) codes. Additional work is needed to complete and to validate the analysis efforts, e. g., use the direct simulation Monte Carlo (DSMC) computational tools to provide an independent validation of the flow field at these low-density gas conditions. The modeling of the internal flow through the chunnel, starting with a breach of the leading-edge TPS (using the location and the nature of the breach to define the boundary conditions for a few likely initial conditions), and proceeding into the wing is a very complex task that should be completed. Of special interest is matching the computed results to the observed times for (1) the burn through of the MADS wires behind the spars, (2) the burn through of the bundle of wires that ran along the wall of the main left-landing-gear, and (3) the anomalous temperatures measured at various points inside the left main-landing-gear wheel well.

- Wing Leading Edge Subsystem (LESS) comprised of RCC panels, T-Seals, Upper and Lower Thermal Barriers, and associated mounting hardware

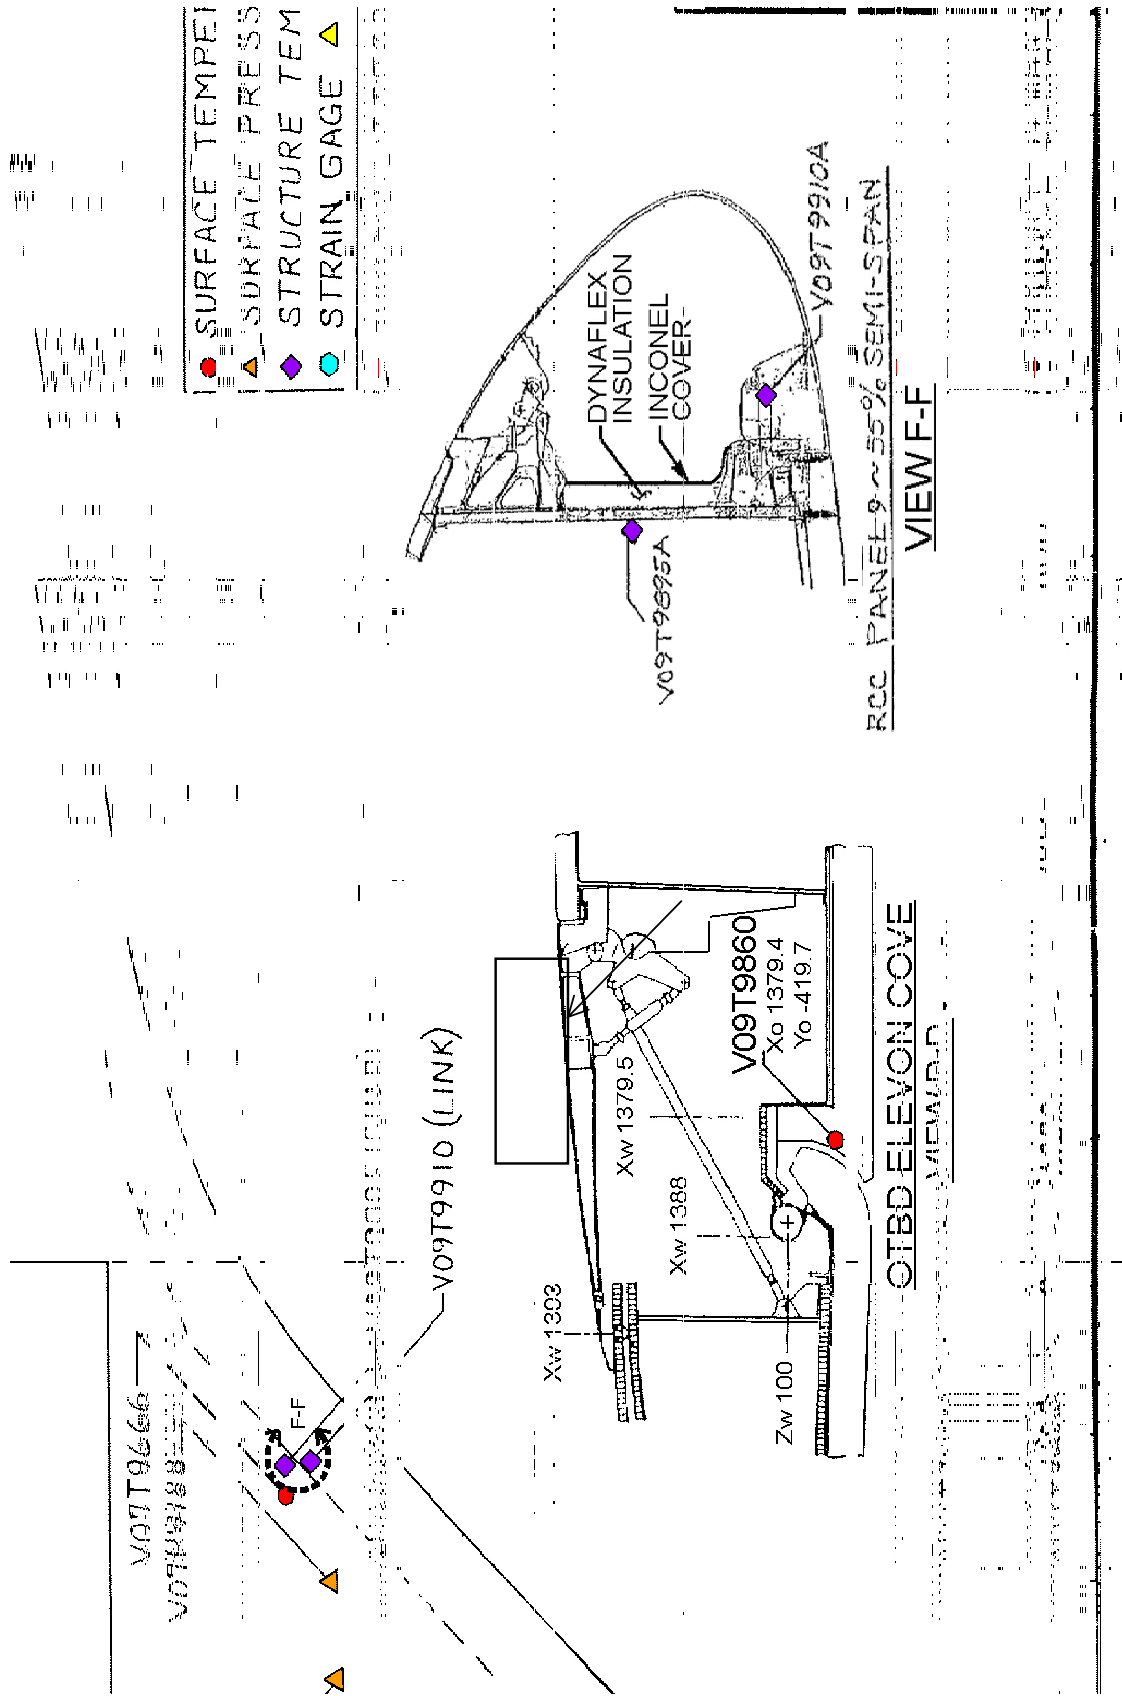
Figure 5

Post-flight analysis of the MADS data indicated a small temperature rise in the measurement from a temperature sensor that was located behind the wing spar of RCC Panel 9. This is a possible additional piece of evidence that the damage occurred during the launch phase.

The authors believe that significant damage to the RCC panels in the vicinity RCC Panel 6 is consistent with the early thermal anomalies that were observed both in the sensors on and/or near the spar at the back of RCC Panel 9 and in some of the sensors in the left main-landing-gear wheel well. The anomalies that occurred in these two regions did not occur simultaneously, but were close in time. Thus, damage somewhere in the vicinity of RCC Panel 6 would be strategically placed to deliver hot gases that could both damage the wires on the back of the wing spar near these RCC panels and the wires on the main left-landing-gear wheel well. The hot gases from the breach in the wing leading edge would also flow down the chunnel (channel/tunnel) that exists between the RCC panels and the spar that follows the wing leading edge, producing the anomalous readings on the sensors at the spar at RCC Panel 9.

RCC Panel 9 Sensor Locations

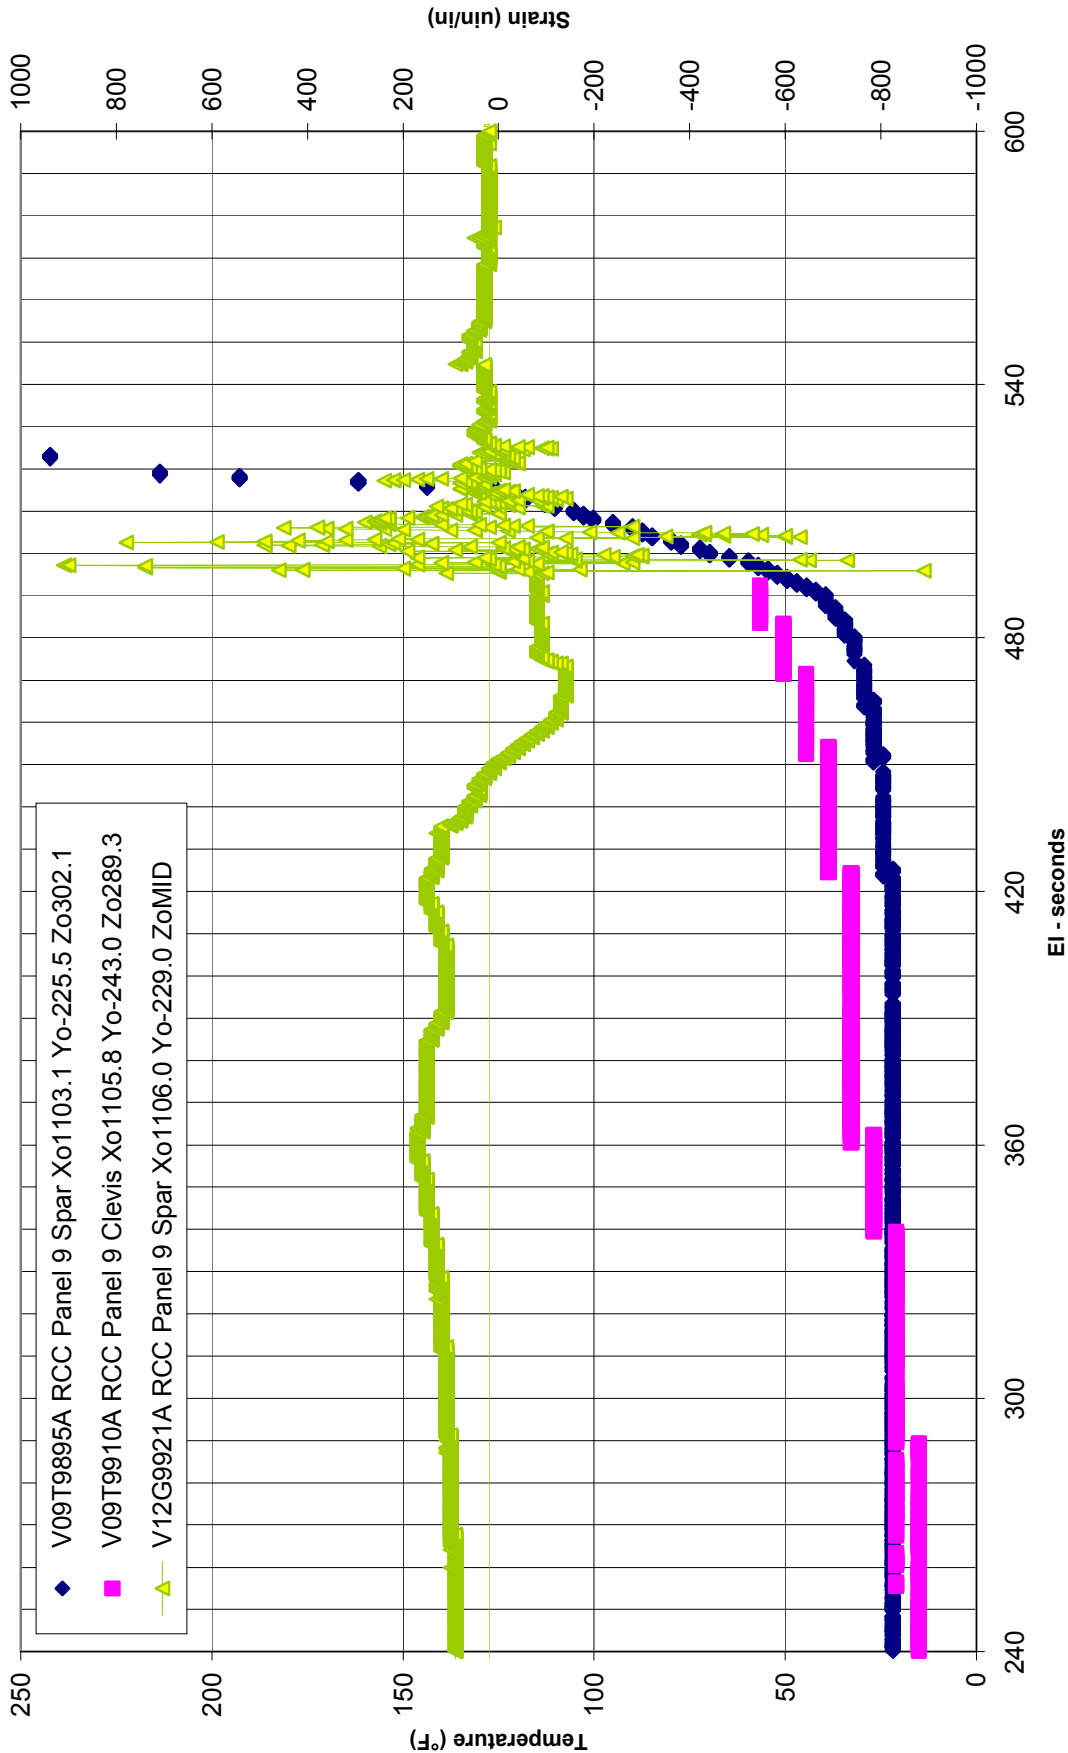
Figure 7

The authors believe that the increase in temperature of the two thermocouples that are located on or near Spar 9 was caused by hot gases entering through a breach in the thermal protection system (TPS), which occurred when the impingement of the ET foam debris damaged the leading-edge TPS. Based on the information currently available to the authors, the critical, it is their opinion that the initial damage probably occurred in the vicinity of RCC Panel 6. Hot gases from the shock layer entered through the breach in the TPS and flowed down the chunnel. Although the density of these gases is relatively low, their temperature is very high. If this is indeed the case, then these hot gases flowing through the chunnel also were destroying the intermediate spar, a. k. a., the transition spar, and parts of the wing spar. Assuming this model to be correct, the hot gases would flow through the gaps and around the edges of the insulative wrap that surrounds the sensors. Thus, convection would be added to conduction and radiation, as mechanisms contributing to the rate at which the measured temperature increases.

STS-107 RCC Panel 9 Spar Temperature & Strain
Clevis Temperature

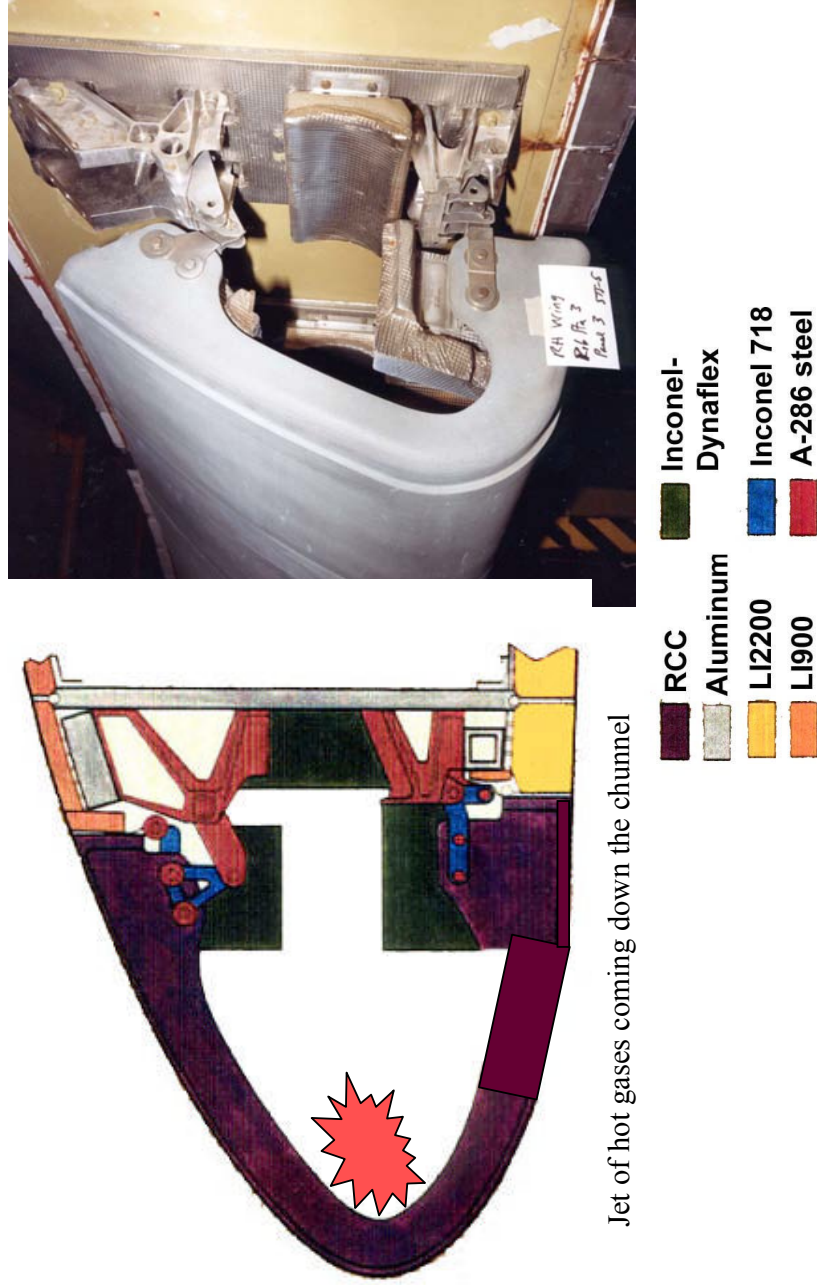
Based on the computed flow-field solutions by NASA and on the engineering experiences of the authors, the flow path of the ingested hot gases depends on the location and on the shape of the breach in the thermal protection system. If the initial damage were a hole in the RCC panel itself, there would be a strong component of flow outward along the chunnel and parallel to the wing leading edge, following the external streamlines. If the initial damage were a piece of T-seal, the ribs of the bounding RCC

panels would constrain the flow to the channel bounded by the ribs. This flow path is initially perpendicular to the wing leading edge. However, the high temperature gases flowing in this channel could quickly ablate the downstream rib, at which time the damage would function as a hole.

Hot gases enter the channel

- Flow behind RCC
- Outward through Chunnel

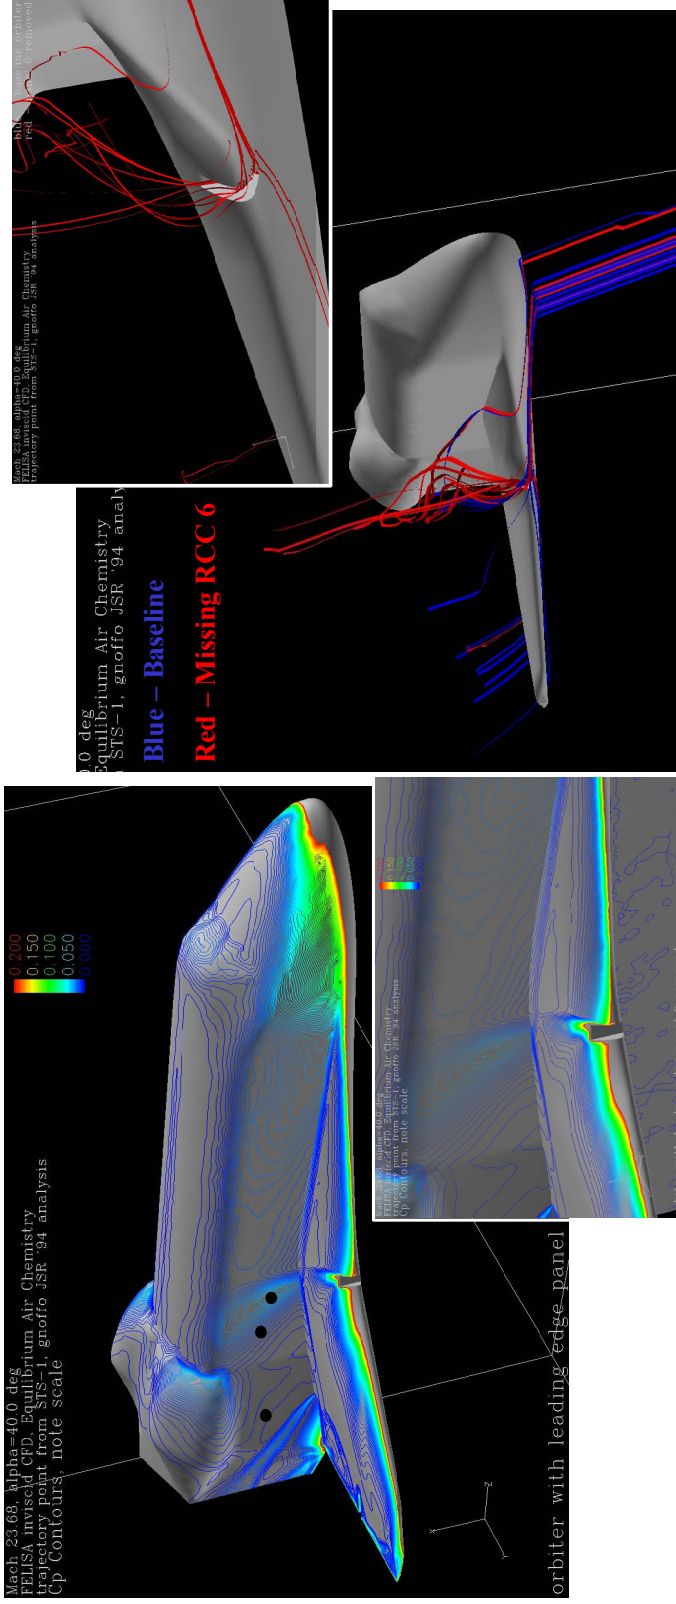
- “(1) Produces negative roll and yaw moments w/small magnitude
- (2) Streamlines for the damaged vehicle track inboard of baseline
- (3) Resultant shock raises pressures in proximity to temp measurements”.

From GMT 13:53:00 to GMT 13:54:00, the delta rolling moments are negative (left-wing down) and becoming more negative with time. See Figure 30. In the same time frame are the first five debris events. Recall that, for the flow field that was computed for the Orbiter with RCC Panel 6 missing, there were negative rolling moments of small magnitude. See Figure 12.

Orbiter with RCC Panel 6 Removed – Mach 23.8

- Produces negative roll and yaw moments w/small magnitude
- Streamlines for damaged vehicle track inboard of baseline
- Resultant shock raises pressure in proximity to temp measurement

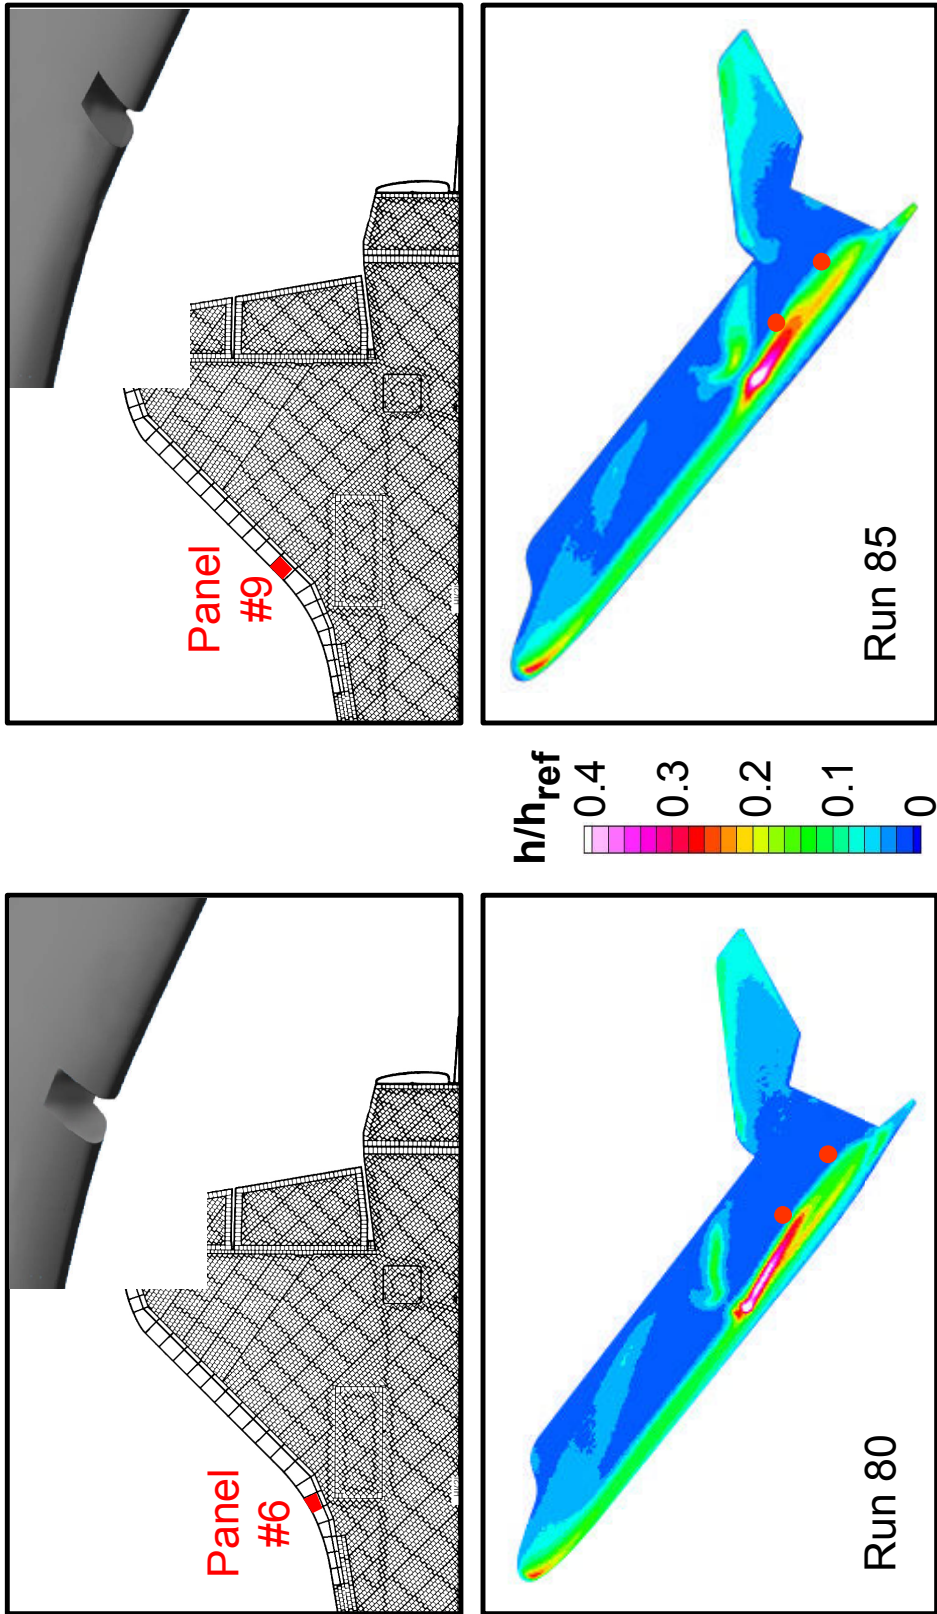
Panel 6 vs. Panel 9

Side fuselage heating 2 to 10 times nominal configuration heating.

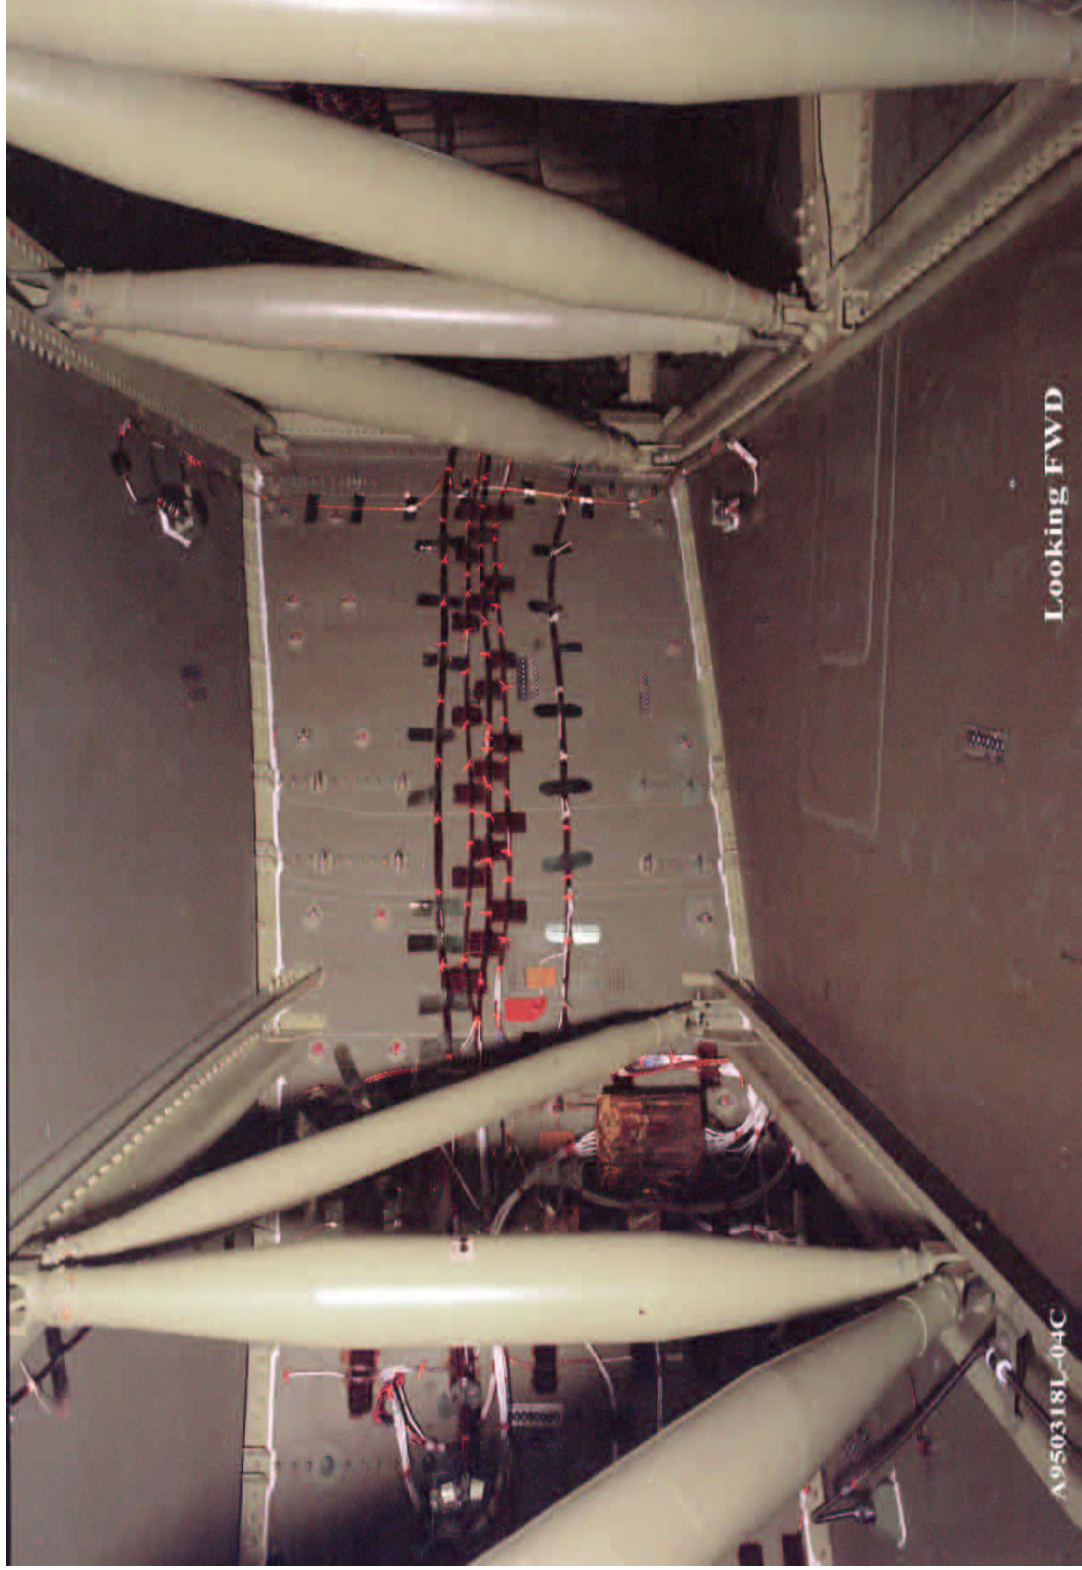
Figure 16

Several of the wires carrying signals from the MADS sensors (including the two temperature measurements behind RCC Panel 9, one on the clevis and one behind the spar) run behind the RCC Panel 9 area wing spar along the back of the spar, forward to the front of the wheel well (about RCC Panel 5). See Figures 16 and 17. At EI + 487, the sensors whose wires run on the back of the left wing front spar begin going off-line, indicating a burn through of the spar. Over the next 10 seconds most of these signals go off line. The last one, the bottom-most wire, goes off-line at EI + 522. Since these wires are separated by about eighteen inches in most locations, the breach, at least its vertical dimension, had to be quite large. Beginning at approximately GMT 13:52:59, which is equivalent to EI + 530, the wires in the large bundles that run along the top of the wheel well (See Figure 17 and 18) begin to go off line. The first signal to go off line was the elevon lower skin temperature. Over the next minute or so most of the signals in these wire bundles go off line. See Figure 19. This would indicate a significant amount of heat was impinging on the wires and wheel well wall. NASA has performed a number of tests to investigate the burning of wire bundles. These test demonstrated that the rapid loss of the entire wire bundle requires very hot gases, with local heat rates of 80 to 90 Btu/ft²-sec. It is likely that the wheel well wall had been penetrated at this time, since anomalies were showing up in the temperature measurements in the left main-landing-gear wheel well. Recall that the first observed "bit flip" in the wheel well was at EI + 488. While this single "bit flip" may or may not be significant by itself, within the next one to two minutes most of the temperature sensors on the landing gear in the wheel well began to increase. Refer to the discussion of "critical data/event" #6.

3. The hole through the spar has some defining characteristics. It has to burn all 4 MADS wire bundles on the back of the spar (making it about 18 inches high), yet focus enough heat on the OI (telemetry) wire bundles several feet away on the top of the wheel well to burn them quickly. A missing T-seal (or a portion thereof) near RCC Panel 6 \pm one panel would allow a concentrated slit of hot gases to cut the wire bundles, without depositing heat to a large internal volume in the wheel well. Since the temperature sensors in the wheel well all increase together, but at a very slow rate (about 8 degrees per minute), the plume can't be impinging directly on these temperature sensors. Within a few minutes, the slit jet will change to a "circular" hole as the downstream rib burns through. The change in the geometry of the breach causes more of the hot gases to flow down the chunnel.

MADDS Wires on Back of Spar RCC 9 and 8

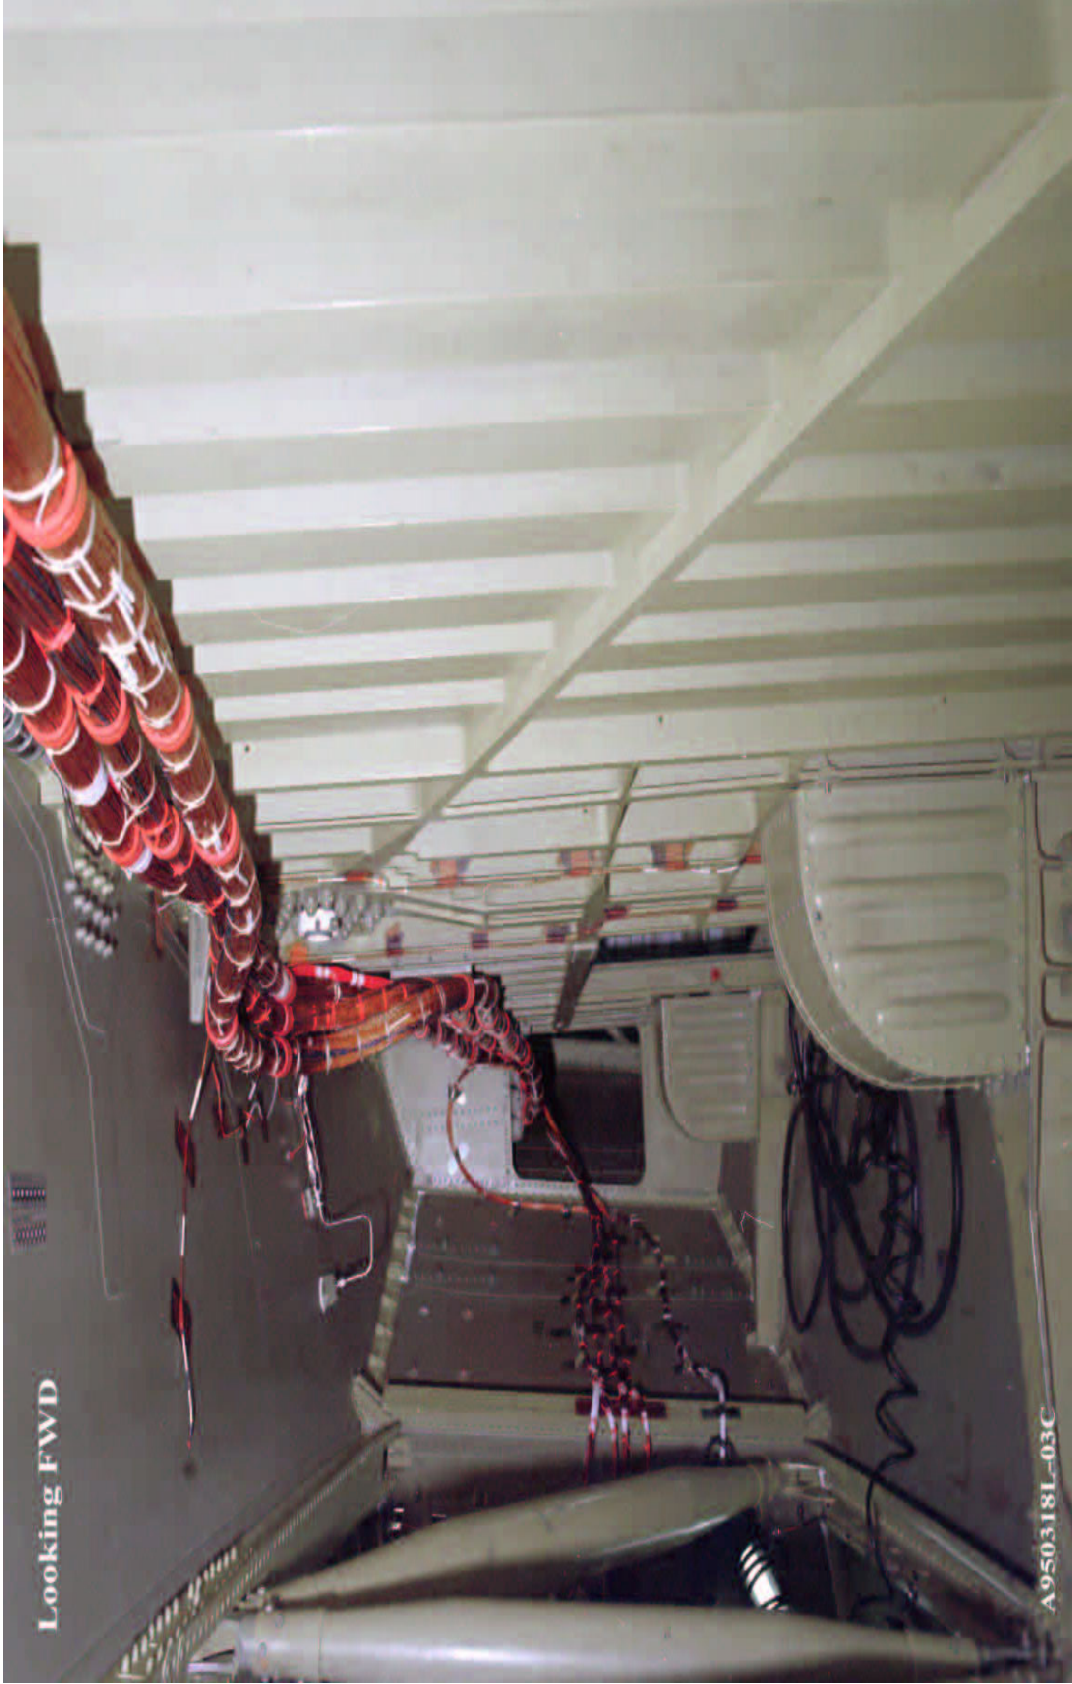
Figure 17

MADDS Wires on Back of Spar RCC 7 and 6 and IO Wires on Wheel Well

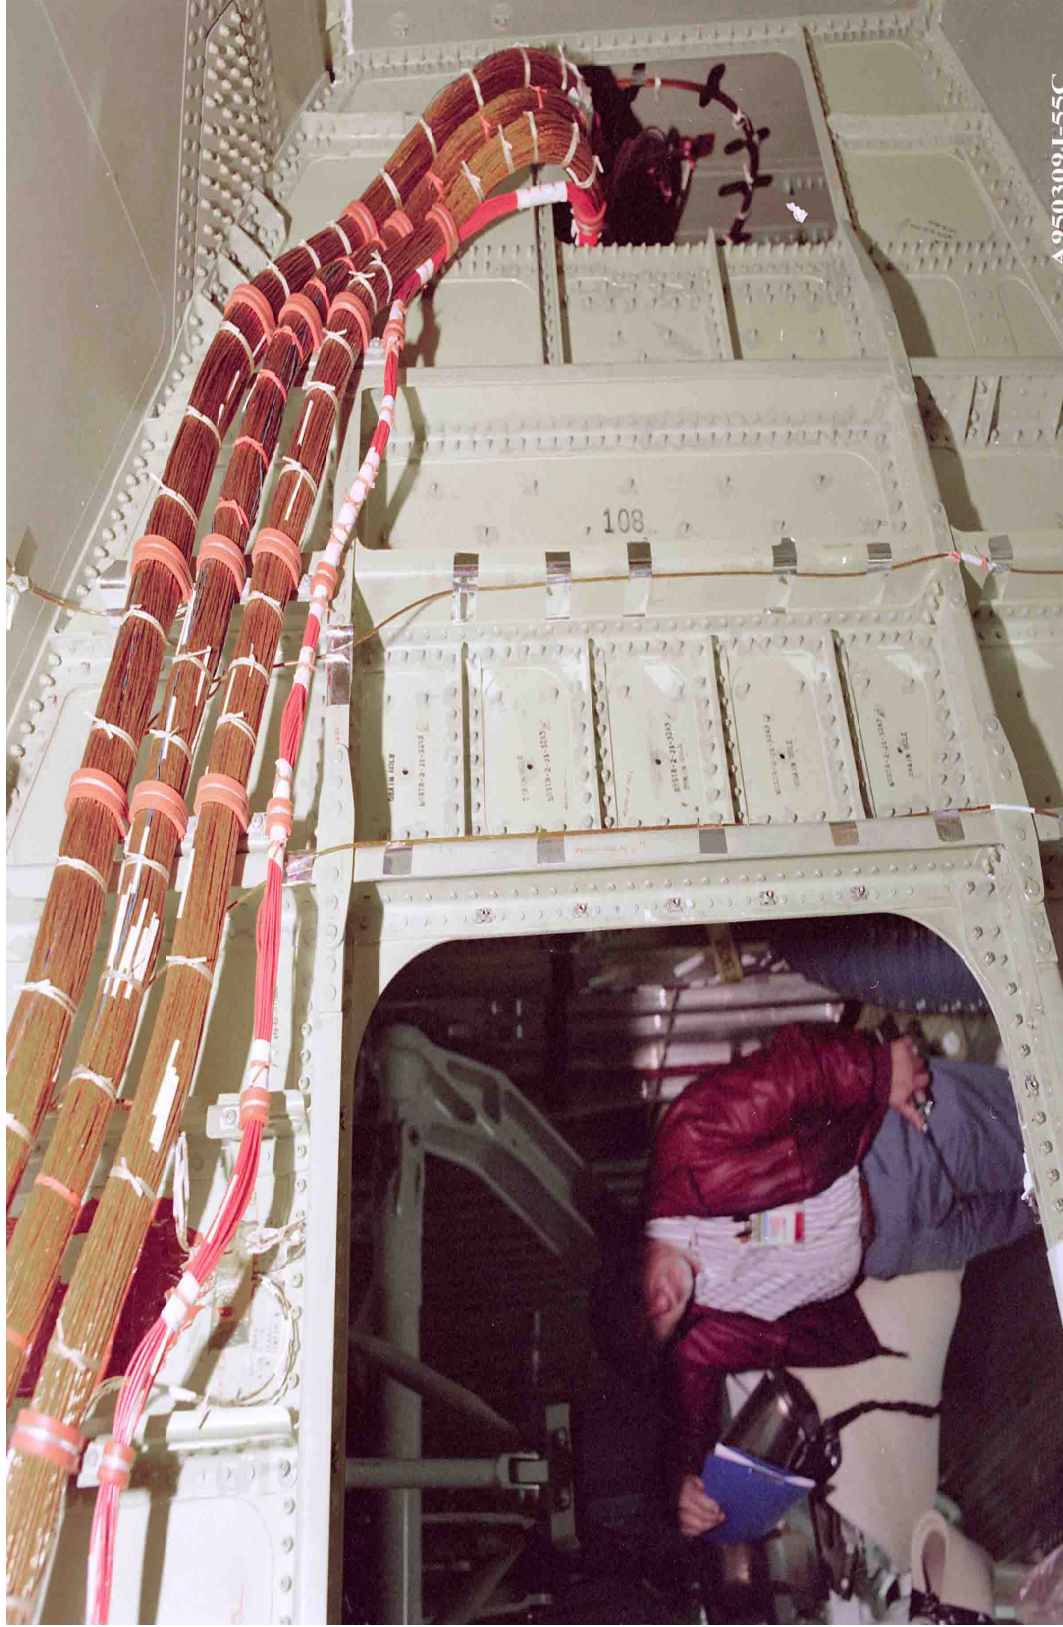
Figure 18

RCC Spar 5 on MADDs and OI Wires on Front of Wheel Well

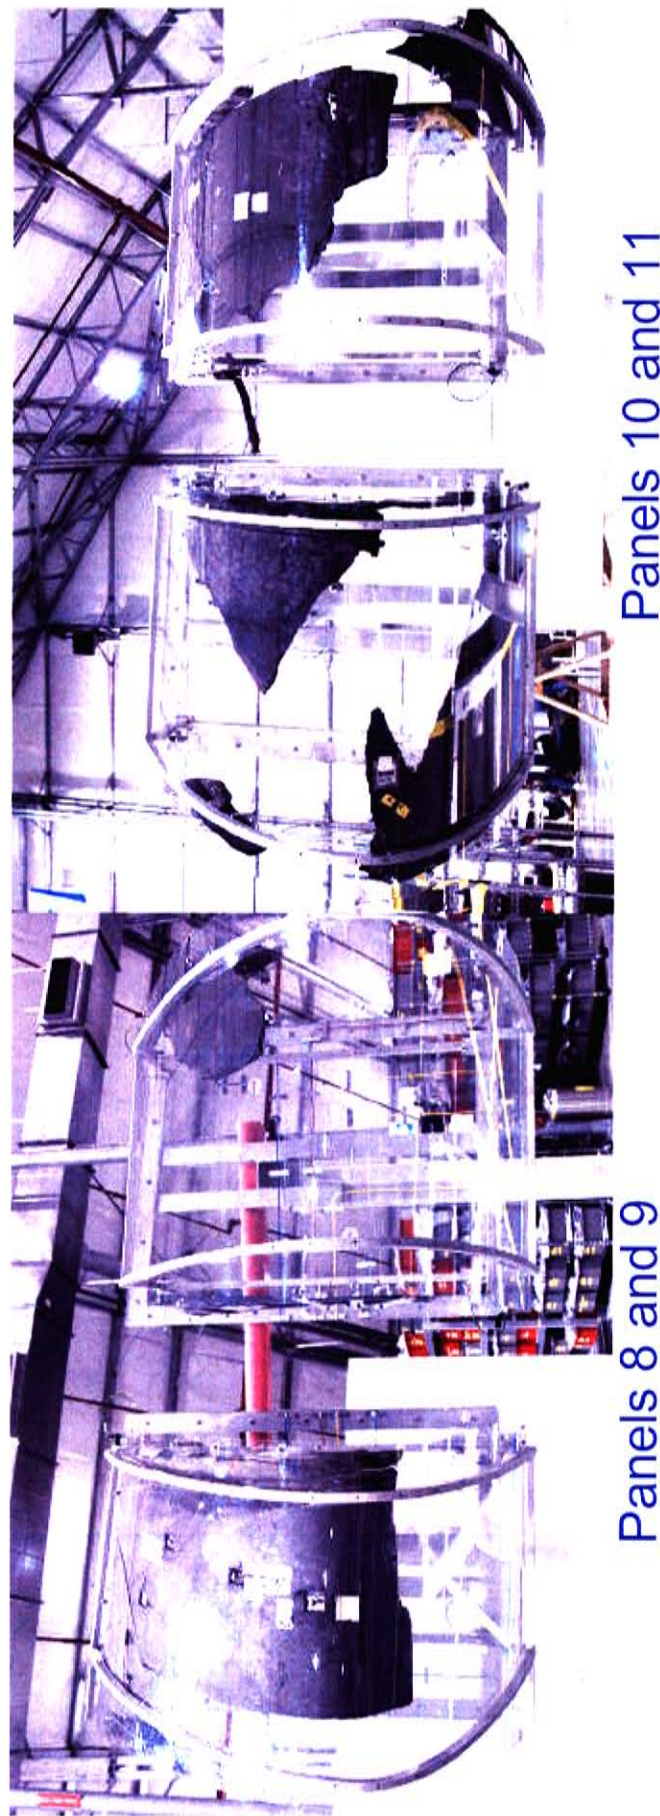
The experts report that there is a lot of unique damage in the vicinity of RCC Panels 8 and 9, noting that there is considerable slag deposited on the inner surfaces of the upper portions of the recovered panels. The relative metallic deposition on left wing materials is presented in Figure 21. Note that the metallic deposition is "heavy" to "very heavy" behind RCC Panels 7, 8, 9, and 10. Since the predominate flow stream will be up and out along the chunnel, this pattern would be consistent with an initial breach in the vicinity of RCC Panel 6 +/- 1 panel with the hot gas plume impinging on the spar behind RCC Panels 7 and 8, causing splatter on the material in this area.

The authors believe the recovered portions of RCC Panels 6 through 10 are reasonably consistent with the demise history of the panels that will apply to "critical data/event" #10. Moving circumferentially around the wing leading edge in an x-y plane, the most severe convective heating occurred in the vicinity of the stagnation line in the shock/shock-interaction region, which is most severe for RCC Panel 9 \pm one panel. See Figure 9. The burn through started at the stagnation line and proceeded to eat away the RCC shell in either direction. Thus, it is not surprising that the lower surface has not been found for any of these RCC panels. The hot gases flowing through the chunnel from the original ET foam-induced breach to the thermal protection system (TPS), which occurred in the vicinity of RCC Panel 6 +/- 1 panel, ate away at numerous metal surfaces, depositing the residue as slag on the surviving inner surfaces of the leading edge TPS elements.

Deposits and Erosion Indicate an Outboard Flow

Substantially Less RCC Material

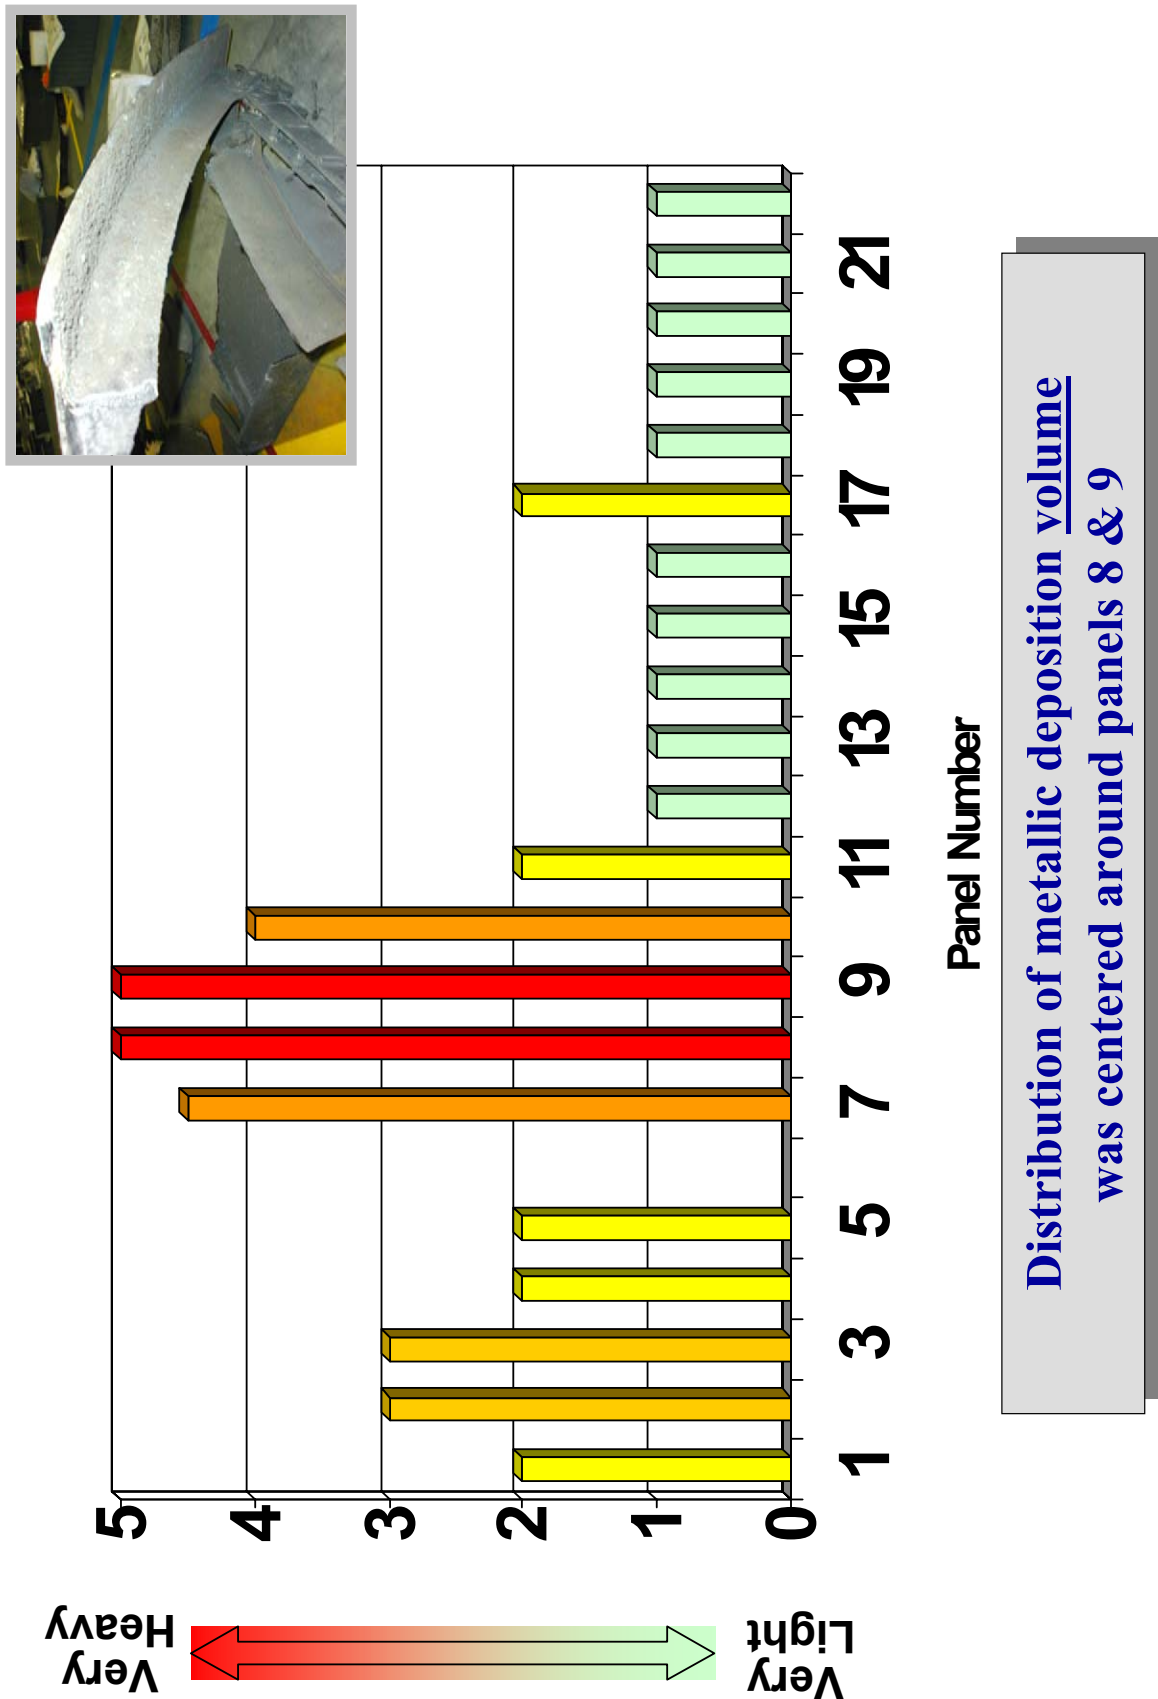
Figure 21

Relative Metallic Deposition on Left Wing Materials
